The following are the PLANS that have been derived of the ORIGINAL structure of the Byrne-Reed House after preliminary investigation. Detailed investigation is ongoing.

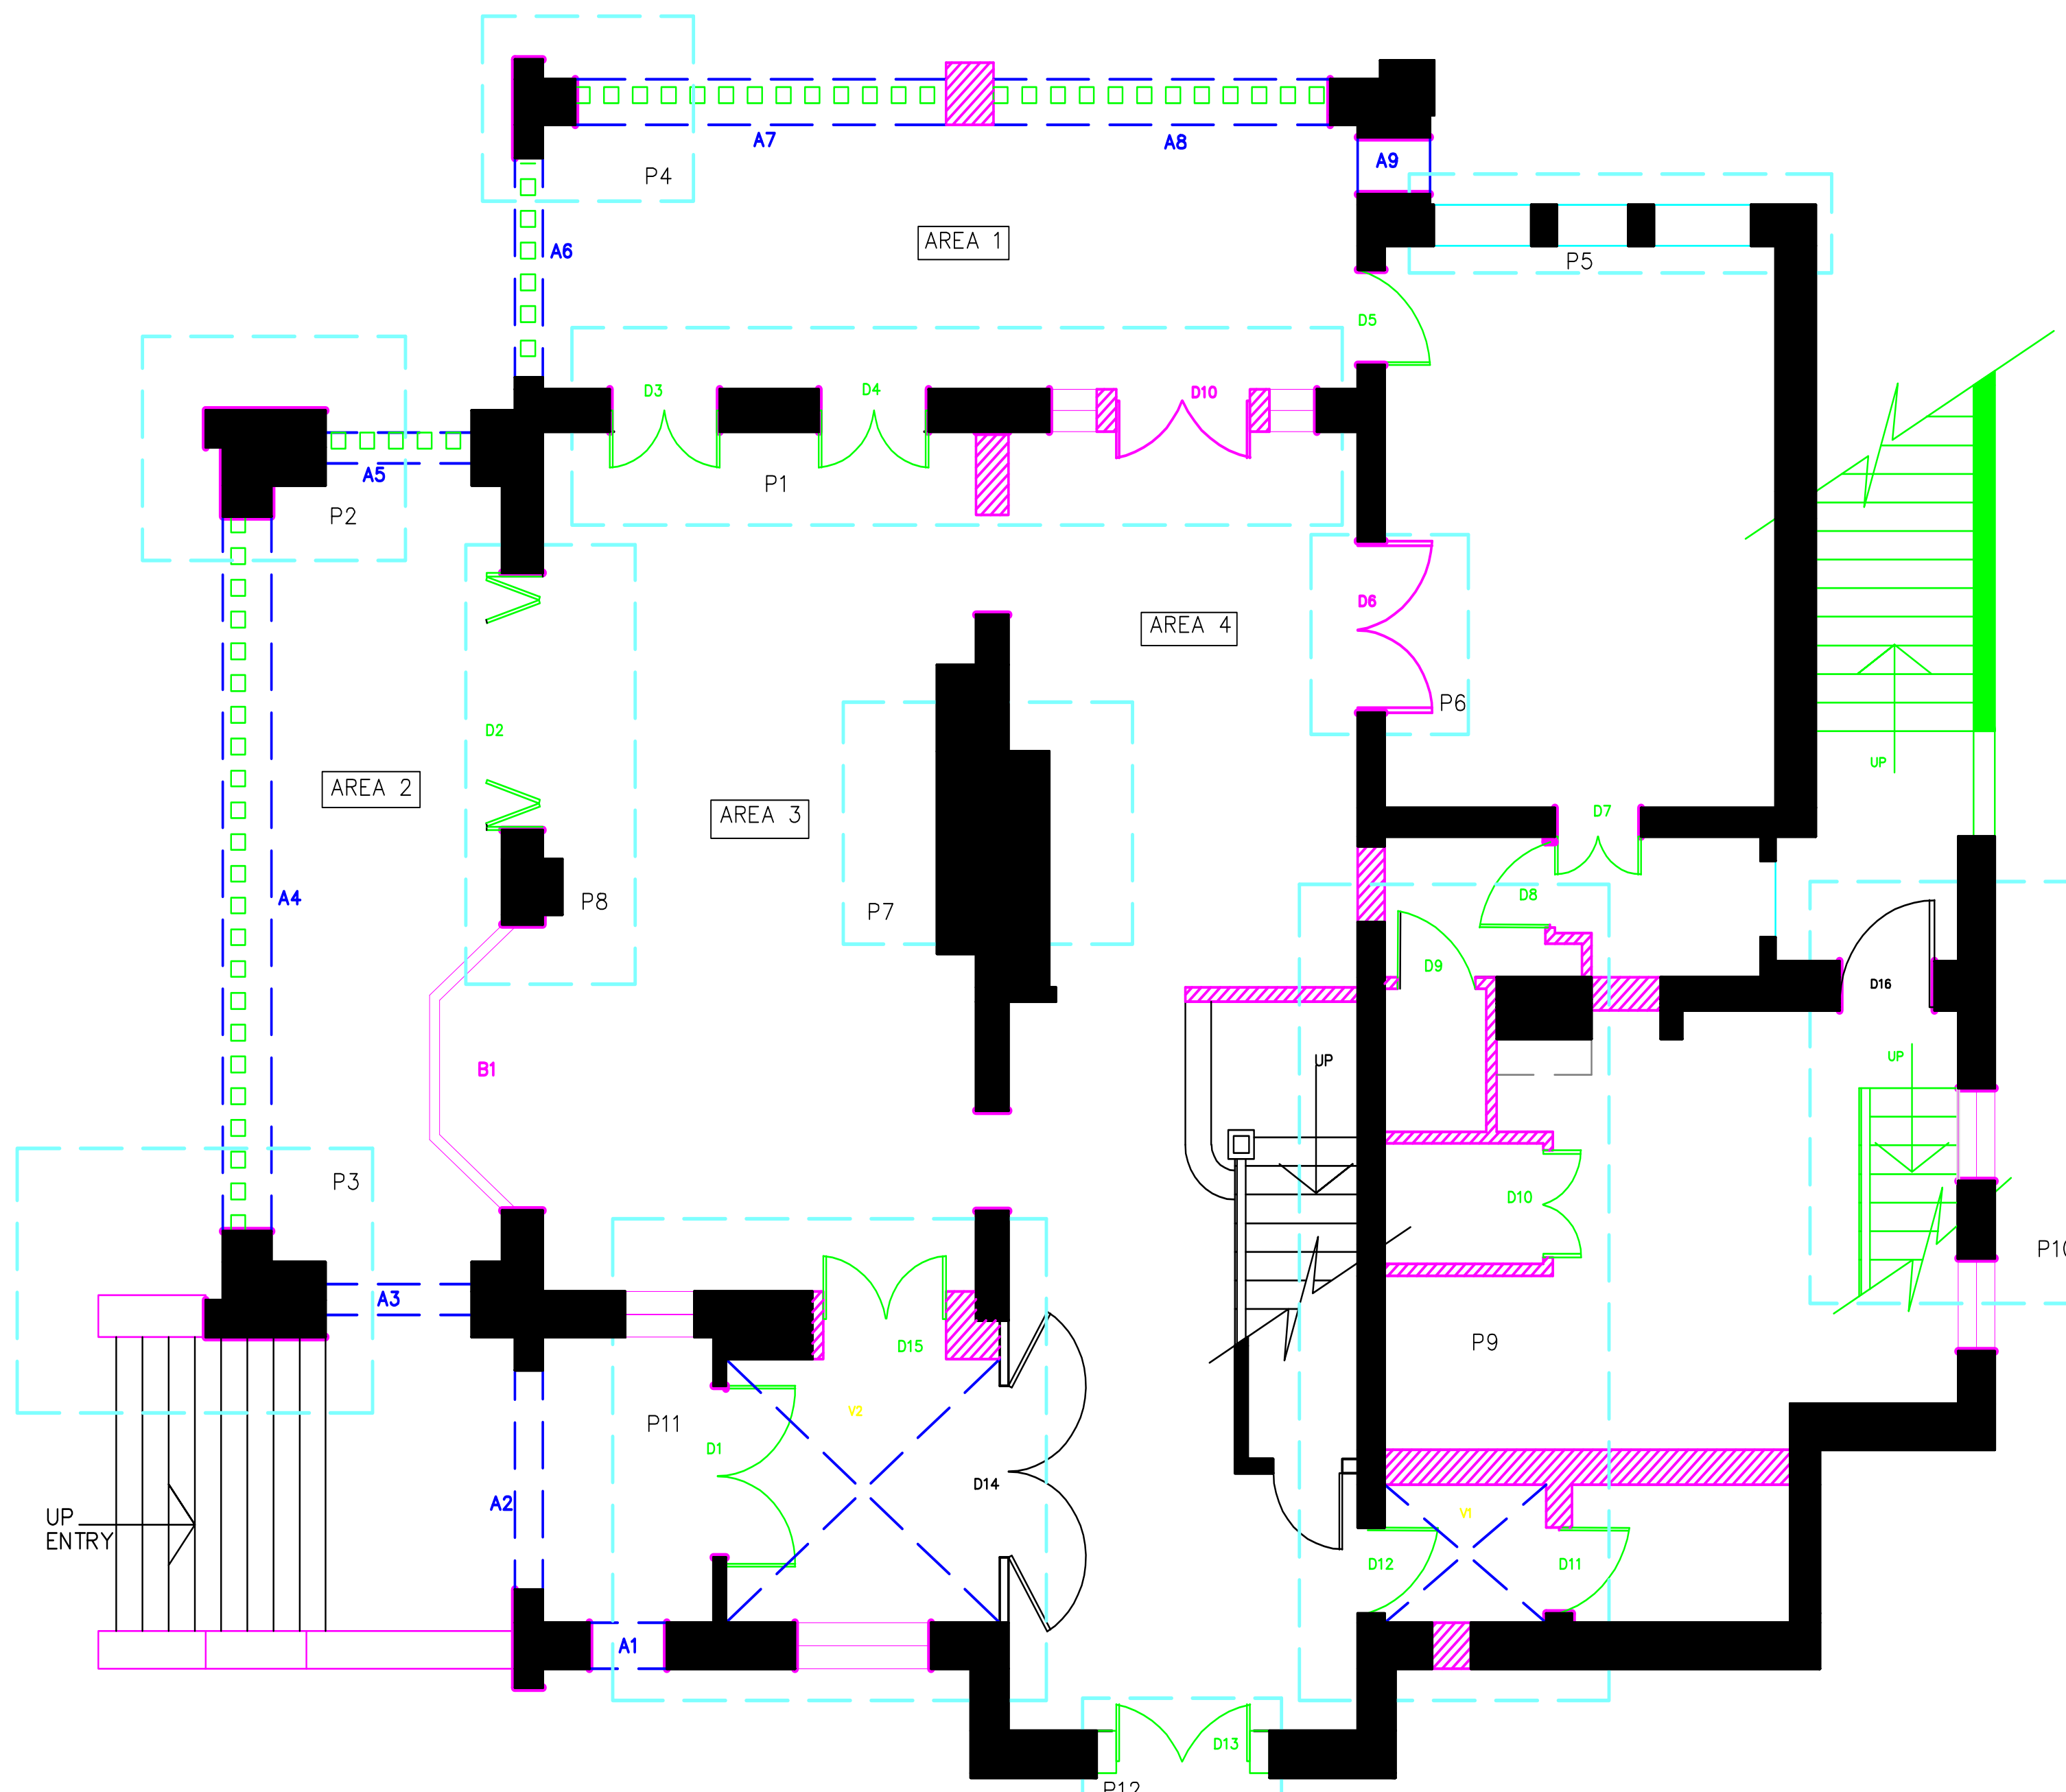
## ORIGINAL FIRST FLOOR PLAN

- P1-Green had been doors ripped off. Magenta door evidence exists-needs replacement to original.
- P2 /P3/P4-  
-Small Arch embedded in the existing wall. Big arch most likely removed.

- P5-Existing lighting not original.
- P6-Evidence of original door in the found. Existing door needs replacement.
- P7-Two fireplaces. Not accessible above false ceiling for further investigation. But seem to have some evidence embedded in the duct area.

- P8-Wall is thicker. It could be due to structural reasons. Investigation needed. Door opening size is fixed but the characteristics of the door shutters etc. are not known.

- P9- Completely ripped off the original structure. Needs many alterations and additions as shown in the plans. Original fireplace next to it is missing. Needs investigation. Two walls need to be shortened to 3' 0" in height. Light fixture in the center of the vault is missing.

- P10-A staircase may have existed. There is some evidence of it.
- P11-Missing light fixture at the center of the vault. A small arched window and another window from the original structure are missing from external wall. Some original doors ripped off.

- P12-D13 was not original entrance. D10 may to be equal to D13.

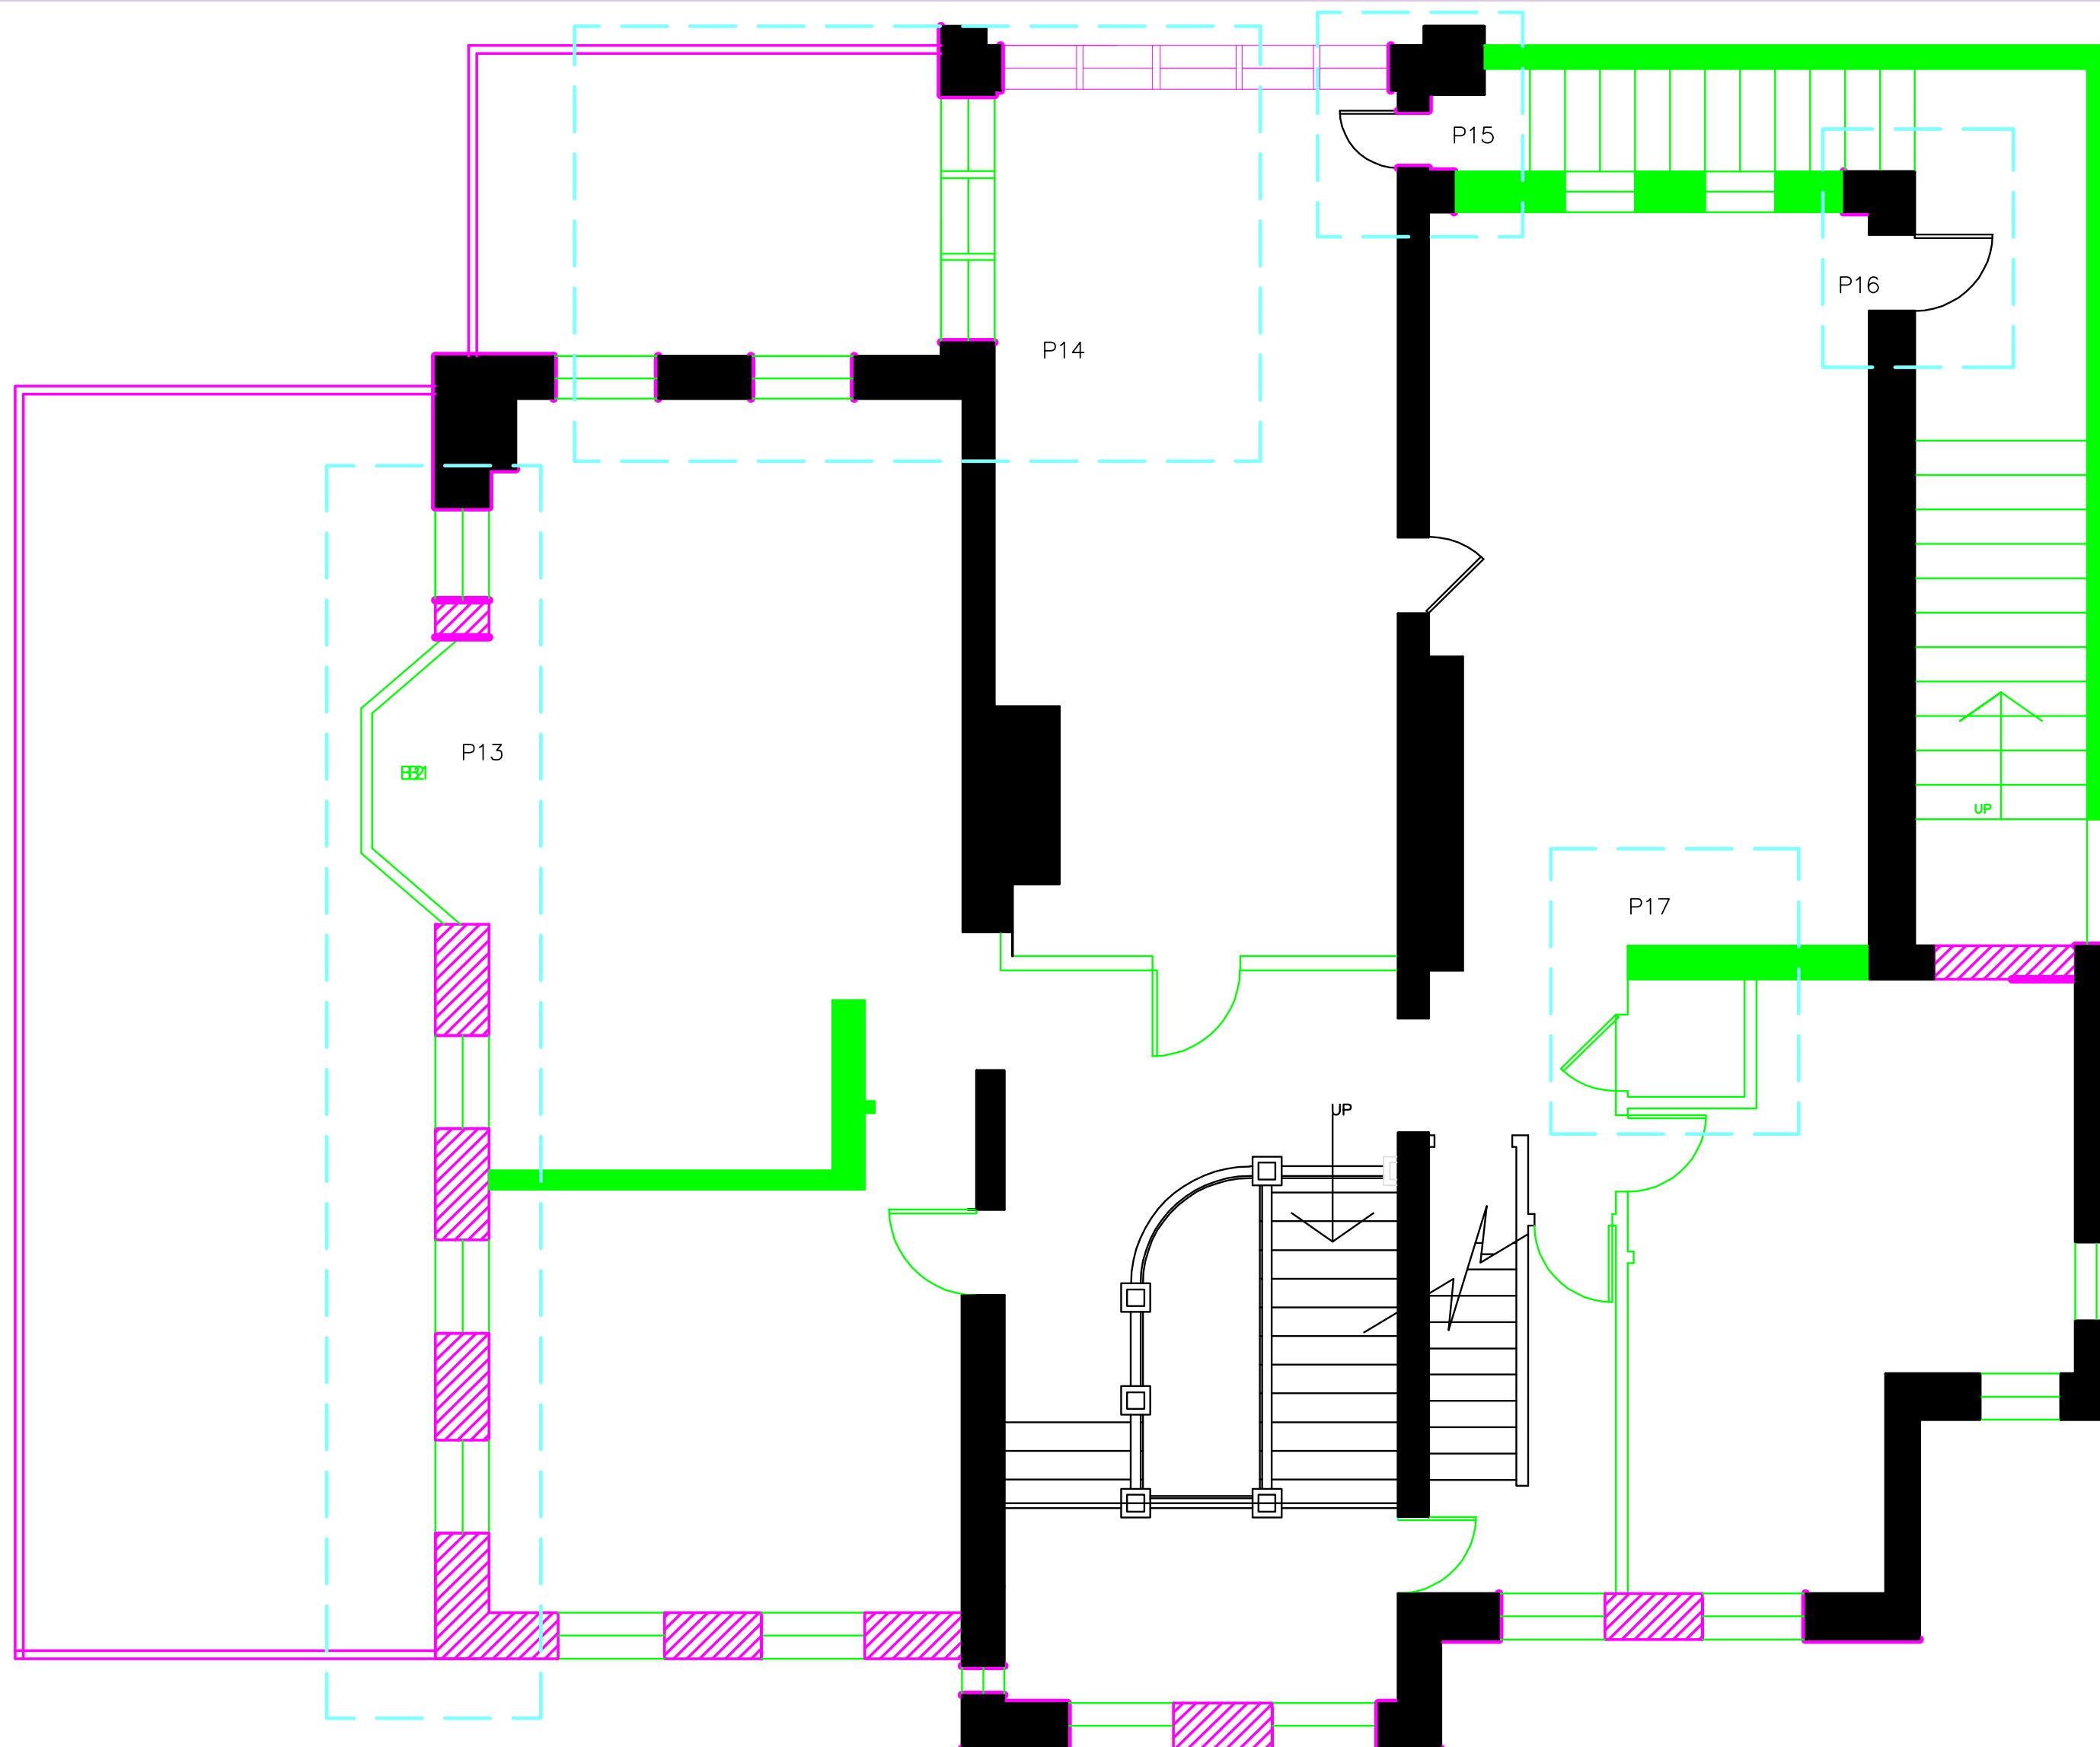
## ORIGINAL SECOND FLOOR PLAN

- P13-Scanty evidence of bay windows and other windows. Needs more investigation.
- P14-E boards and acoustical tiles glued.
- P15/P16-Evidence of doors indicating that there may have been a fire escape staircase.
